**FINAL REPORT OF INVESTIGATION**

**SMS 20120703 OCAT#11100**

<b>Date of Event:</b>	July 3, 2012
<b>Type of Event:</b>	Train Evacuation
<b>Incident Time:</b>	17:49 hrs.
<b>Location:</b>	Between E08 and E09 – CM E1 522+00
<b>Time and How received by SAFE:</b>	On-Call Safety Officer
<b>Safety Officer Response:</b>	SAFE Rail Safety On-Call to scene/ [REDACTED]
<b>Time of Safety Officer Arrival:</b>	Notified 1757 hrs.; Arrived 1819 hrs.
<b>Time of Safety Officer Departure:</b>	2005 hrs.

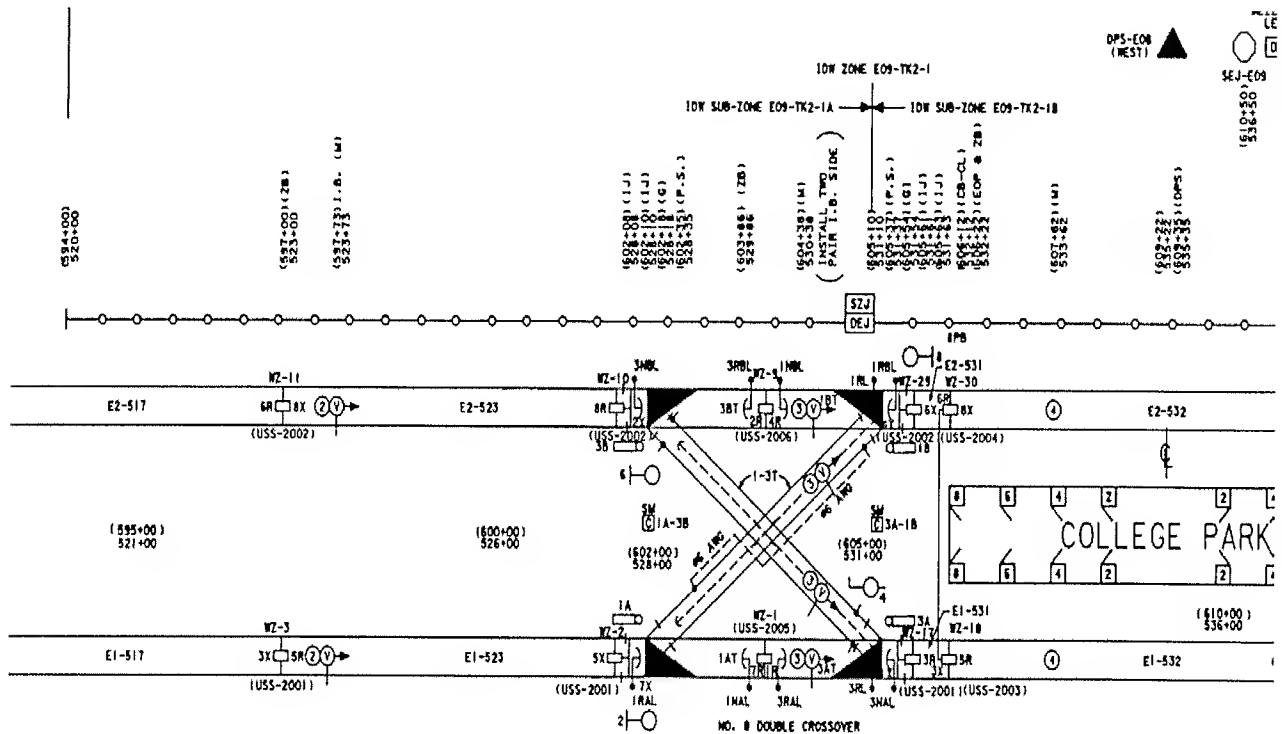
## Field Sketch/Schematics

The incident site is straight Tangent track with a slight descending grade toward the College Park Station.
